April 26, 2017

RE: New York Racing Association, Civil Action No. CV-16-5442,
Aqueduct Racetrack – Quarterly Process Wastewater Report

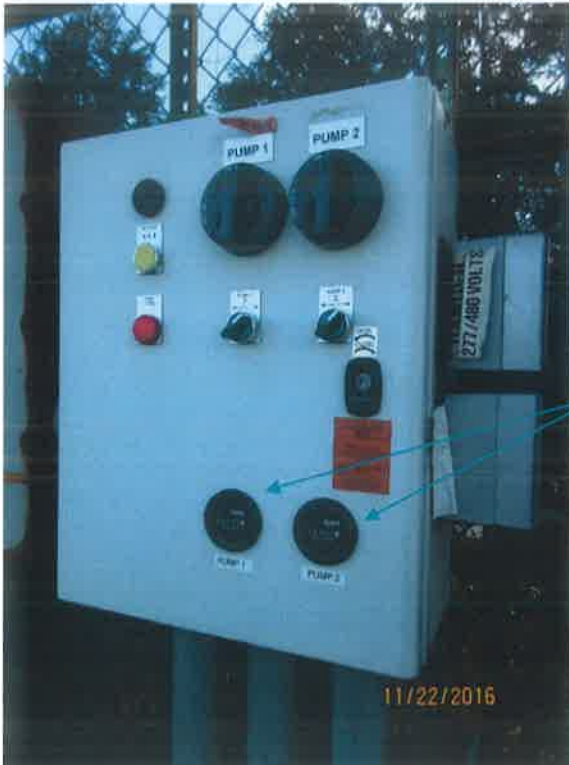
Photograph 1 – Pump run-time meters

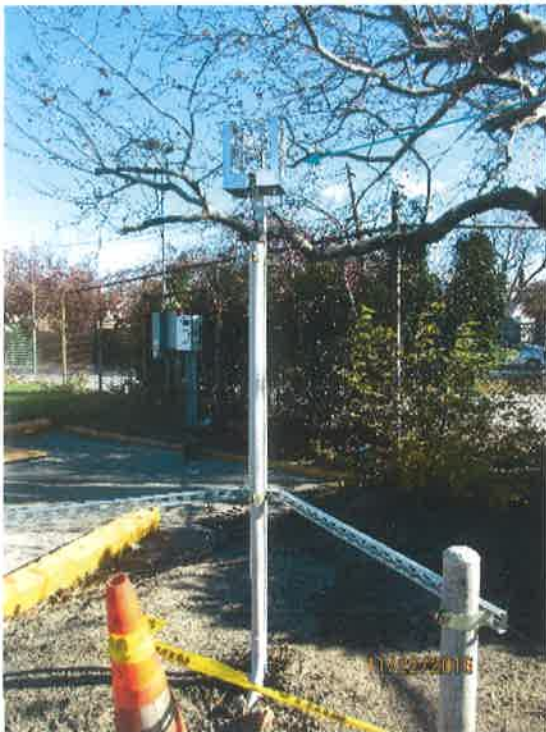
- Barn Area
 - » The southern solar-powered wet sensor malfunctioned as a result of moisture building up in the housing of the electronic component. This condition was noted during 6 of the 13 inspections. The northern solar-powered sensor malfunctioned during 1 of the 13 inspections. Sensors were sent to the manufacturer for repair. NYRA and Monnit personnel are working together to identify how this malfunction can be prevented in the future.

Photograph 2 – Solar powered wet sensor electronic housing

Are solar powered wet sensors in northern and southern stormwater catch basins functional?	Yes/No – Southern sensor is down as a result of moisture getting into the housing. Plexi-glass shelter is being fabricated to prevent this from occurring.
Is pump runtime meter on wet well pump control panel functioning? Is the daily log being filled out?	Runtime hour meter readings – Pump No. 1 - 94 hours, Pump No. 2 - 68 hours

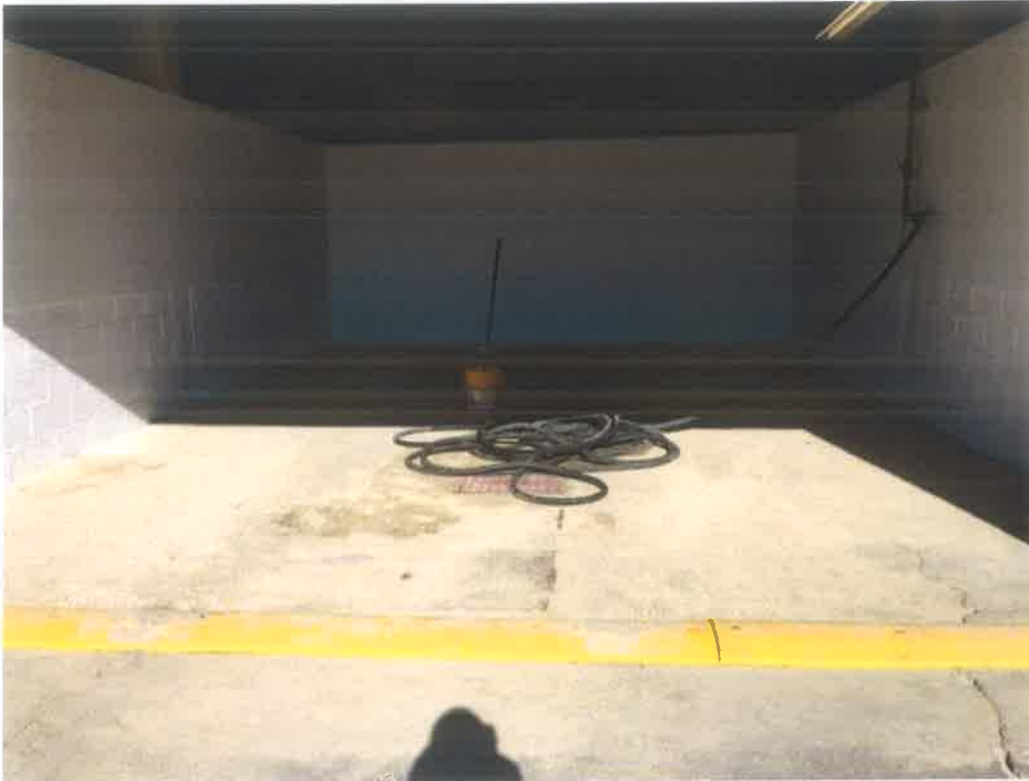
Photograph 3 – New equipment wash bay.
